**Flood Control Project Maintenance
Levee Inspections**

Fall 2018 Levee Maintenance Deficiency Summary Report

**Flood Control Project Maintenance
Levee Inspections****LMA District Cover Sheet
Fall 2018 Levee Inspection Results****Sacramento River West Side Levee District**

Sacramento River West Side Levee District

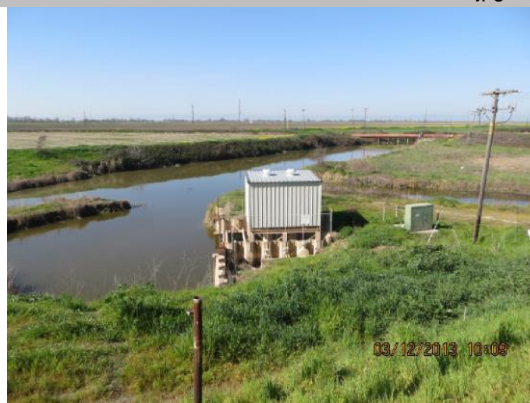
Photo 1 of 3 : UCIP_FA_2018_10087_17235.jpg

LM Start	0.14	Rating **	M	Issue No.	1551
LM End	0.14	Issue Type +	Ma	Location *	
Category	Supplemental			GPS Latitude/Longitude	
				Start	End
Item	DWR UCIP LMA Responsibility			38.801471 °	38.801471 °
				-121.725171 °	-121.725171 °
DWR ID	20224				
Comment Code					
Inspector Comment					
FS_ID:10087 DS_ID:20224 EP_NO: N/A Repair Type: Non-Urgent Crossing Status: Found UCIP Comments: Headwall on WS undermined about 3-4-feet. FIELD_STRUCT_DESC: 1 of 3: 36-inch steel drainage pipe through the levee, 30.0 feet below the crown. Flap gate on the waterside (WS) end. 24-inch pipe sleeved through the 36-inch pipe. Annular space between pipes grouted. Pumps in pump house with walkway on landside (LS) toe. [Additional Reference(s): DWR Levee Log, 2006. USACE Sacramento O&M Manual 130, May 1960 (HLM 0.15)]. FS Date: 3/12/2013

Pumphouse at LS toe.

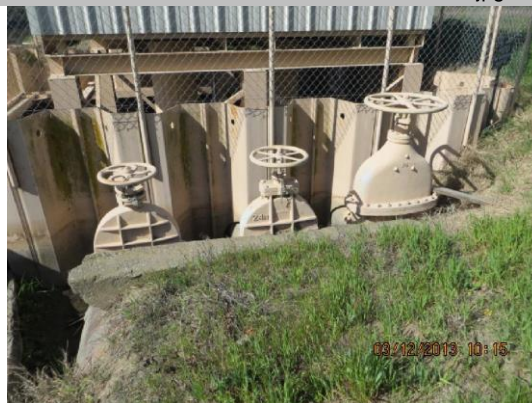
Photo 3 of 3 : UCIP_FA_2018_10087_17233.jpg

LM Start	0.14	Rating **	M	Issue No.	1551 (cont)
LM End	0.14	Issue Type +	Ma	Location *	
Category	Supplemental			GPS Latitude/Longitude	
				Start	End
Item	DWR UCIP LMA Responsibility			38.801471 °	38.801471 °
				-121.725171 °	-121.725171 °
DWR ID	20224				
Comment Code					
Inspector Comment					
FS_ID:10087 DS_ID:20224 EP_NO: N/A Repair Type: Non-Urgent Crossing Status: Found UCIP Comments: Headwall on WS undermined about 3-4-feet. FIELD_STRUCT_DESC: 1 of 3: 36-inch steel drainage pipe through the levee, 30.0 feet below the crown. Flap gate on the waterside (WS) end. 24-inch pipe sleeved through the 36-inch pipe. Annular space between pipes grouted. Pumps in pump house with walkway on landside (LS) toe. [Additional Reference(s): DWR Levee Log, 2006. USACE Sacramento O&M Manual 130, May 1960 (HLM 0.15)]. FS Date: 3/12/2013

Slide gates at pumphouse on LS toe.

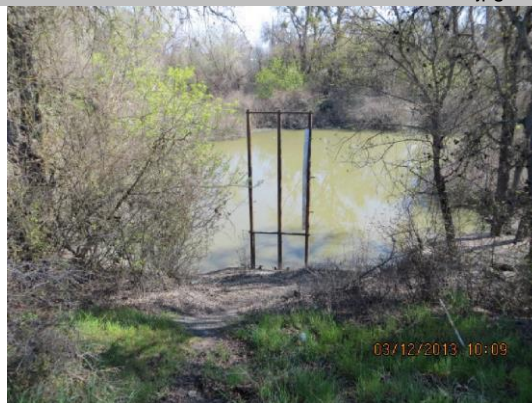
Photo 2 of 3 : UCIP_FA_2018_10085_17226.jpg

LM Start	0.14	Rating **	M	Issue No.	1552
LM End	0.14	Issue Type +	Ma	Location *	
Category	Supplemental			GPS Latitude/Longitude	
				Start	End
Item	DWR UCIP LMA Responsibility			38.801479 °	38.801479 °
				-121.725176 °	-121.725176 °
DWR ID	20356				
Comment Code					
Inspector Comment					
FS_ID:10085 DS_ID:20356 EP_NO: N/A Repair Type: Non-Urgent Crossing Status: Found UCIP Comments: Headwall undermined 3-4-feet on WS toe. FIELD_STRUCT_DESC: 2 of 3: 36-inch steel drainage pipe through the levee, 30 feet below the crown. Flap gate on the waterside (WS) end. 24-inch pipe sleeved through the 36-inch pipe. Annular space between pipes grouted. Pumps inside pump house with a walkway on the landside (LS) toe. [Additional Reference(s): DWR Levee Log, 2006. USACE Sacramento O&M Manual 130, May 1960 (HLM 0.15)]. FS Date: 3/12/2013

Air vents on pipes at WS toe.

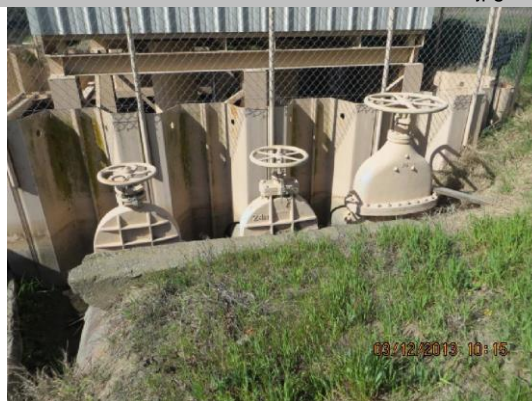
Photo 3 of 3 : UCIP_FA_2018_10085_17225.jpg

LM Start	0.14	Rating **	M	Issue No.	1552 (cont)
LM End	0.14	Issue Type +	Ma	Location *	
Category	Supplemental			GPS Latitude/Longitude	
				Start	End
Item	DWR UCIP LMA Responsibility			38.801479 °	38.801479 °
				-121.725176 °	-121.725176 °
DWR ID	20356				
Comment Code					
Inspector Comment					
FS_ID:10085 DS_ID:20356 EP_NO: N/A Repair Type: Non-Urgent Crossing Status: Found UCIP Comments: Headwall undermined 3-4-feet on WS toe. FIELD_STRUCT_DESC: 2 of 3: 36-inch steel drainage pipe through the levee, 30 feet below the crown. Flap gate on the waterside (WS) end. 24-inch pipe sleeved through the 36-inch pipe. Annular space between pipes grouted. Pumps inside pump house with a walkway on the landside (LS) toe. [Additional Reference(s): DWR Levee Log, 2006. USACE Sacramento O&M Manual 130, May 1960 (HLM 0.15)]. FS Date: 3/12/2013

Slide gates at pumphouse on LS toe.

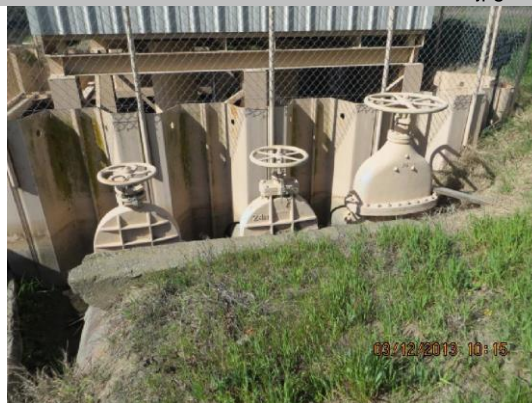
Photo 3 of 3 : UCIP_FA_2018_10910_18183.jpg

LM Start	0.14	Rating **	M	Issue No.	1553 (cont)
LM End	0.14	Issue Type +	Ma	Location *	
Category	Supplemental			GPS Latitude/Longitude	
				Start	End
Item	DWR UCIP LMA Responsibility			38.801491°	38.801491°
				-121.725184°	-121.725184°
DWR ID	20357				
Comment Code					
Inspector Comment					
FS_ID:10910 DS_ID:20357 EP_NO: N/A Repair Type: Non-Urgent Crossing Status: Found UCIP Comments: Headwall undermined 3-4-feet on WS toe. FIELD_STRUCT_DESC: 3 of 3: 36-inch steel drainage pipe through the levee, 30 feet below the crown. Flap gate on the waterside (WS) end. 24-inch pipe sleeved through the 36-inch pipe. Annular space between pipes grouted. Pumps inside pump house with a walkway on the landside (LS) toe. [Additional Reference(s): DWR Levee Log, 2006. USACE Sacramento O&M Manual 130, May 1960 (HLM 0.15)]. FS Date: 3/12/2013

Slide gates at pumphouse on LS toe.

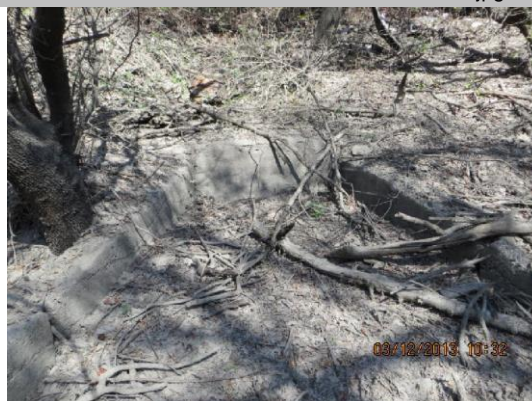
Photo 1 of 1 : UCIP_FA_2018_10088_17237.jpg

LM Start	0.22	Rating **	A/W	Issue No.	1554	
LM End	0.22	Issue Type +	Ma	Location *		
Category	Supplemental			GPS Latitude/Longitude		
				Start	End	
Item	DWR UCIP LMA Responsibility			38.802293 °	38.802293 °	
				-121.724847 °	-121.724847 °	
DWR ID	20327					
Comment Code						
Inspector Comment						
FS_ID:10088						
DS_ID:20327						
EP_NO: N/A						
Repair Type: No Action Needed						
Crossing Status: Found						
UCIP Comments:						
FIELD_STRUCT_DESC: *ABANDONED* 42-inch drainage pipe of an unknown material through the levee, 28.5 feet below the crown.						
Abandoned in place by plugging with concrete. Headwall on waterside (WS) toe. [Additional Reference(s): USACE Sacramento O&M Manual 130, May 1960 (HLM 0.22)].						
FS Date: 3/12/2013

Concrete headwall visible on WS toe.

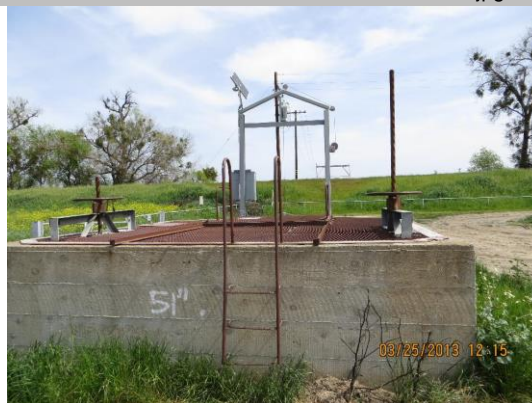
Photo 1 of 3 : UCIP_FA_2018_10103_17262.jpg

Comment Code					
Inspector Comment					
FS_ID:10103 DS_ID:20226 EP_NO: 1331 Repair Type: Non-Urgent Crossing Status: Found UCIP Comments: There is no gate in the slide gate at the concrete distribution box off the landside toe. This may not be an issue as there is a slide gate at the WS toe. FIELD_STRUCT_DESC: 54-inch corrugated metal irrigation pipe through the levee, 28 feet below the crown. Vertical pumps on a pile structure in the stream. Walkway to pumps. Flap gates from pumps and slide gate inside a 7-foot by 10-foot concrete surge box on the waterside (WS), 1948 installation. 15-foot by 18-foot concrete distribution box 150 feet off landside (LS) toe with slide gate. (Permit No. 1331, 1948 - River Farms Company of California). [Additional Reference(s): DWR Levee Log, 2006. USACE Sacramento O&M Manual 130, May 1960 (HLM 0.47)]. FS Date: 3/25/2013 7:36:51 AM

Concrete distribution box on 150-feet off landside toe.

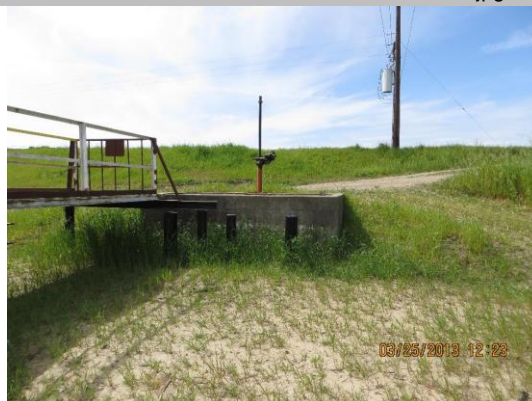
Photo 3 of 3 : UCIP_FA_2018_10103_17260.jpg

Comment Code						
Inspector Comment						
FS_ID:10103 DS_ID:20226 EP_NO: 1331 Repair Type: Non-Urgent Crossing Status: Found UCIP Comments: There is no gate in the slide gate at the concrete distribution box off the landside toe. This may not be an issue as there is a slide gate at the WS toe. FIELD_STRUCT_DESC: 54-inch corrugated metal irrigation pipe through the levee, 28 feet below the crown. Vertical pumps on a pile structure in the stream. Walkway to pumps. Flap gates from pumps and slide gate inside a 7-foot by 10-foot concrete surge box on the waterside (WS), 1948 installation. 15-foot by 18-foot concrete distribution box 150 feet off landside (LS) toe with slide gate. (Permit No. 1331, 1948 - River Farms Company of California). [Additional Reference(s): DWR Levee Log, 2006. USACE Sacramento O&M Manual 130, May 1960 (HLM 0.47)]. FS Date: 3/25/2013 7:36:51 AM

Vents for 3 pipes entering surge box on WS toe.

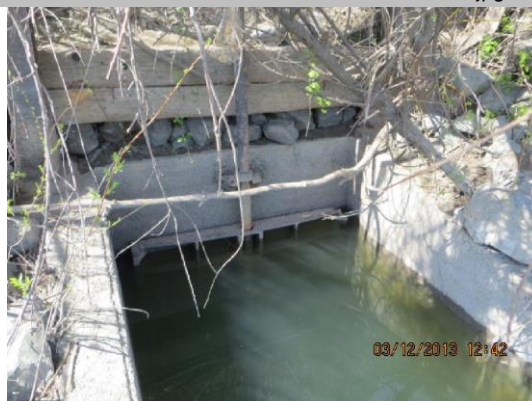
Photo 3 of 3 : UCIP_FA_2018_10125_17281.jpg

LM Start	3.54	Rating **	A/W	Issue No.	1556 (cont)	
LM End	3.54	Issue Type +	Ma	Location *		
Category	Supplemental			GPS Latitude/Longitude		
				Start		End
Item	DWR UCIP LMA Responsibility			38.846492 °		38.846492 °
				-121.730066 °		-121.730066 °
DWR ID	20331					
Comment Code						
Inspector Comment						
FS_ID:10125 DS_ID:20331 EP_NO: N/A Repair Type: No Action Needed Crossing Status: Found UCIP Comments: FIELD_STRUCT_DESC: 5-foot by 5-foot reinforced concrete box drainage tunnel through the levee, 33 feet below the crown. Slide gate at outlet on the waterside (WS) toe. Tunnel runs from concrete U-shaped riser unit on the landside (LS) shoulder to the WS toe. Steel walkway to slide gate actuator on the WS berm. [Additional Reference(s): USACE Sacramento O&M Manual 130, May 1960 (HLM 3.59)]. FS Date: 3/12/2013

Slide gate at outlet at river side.

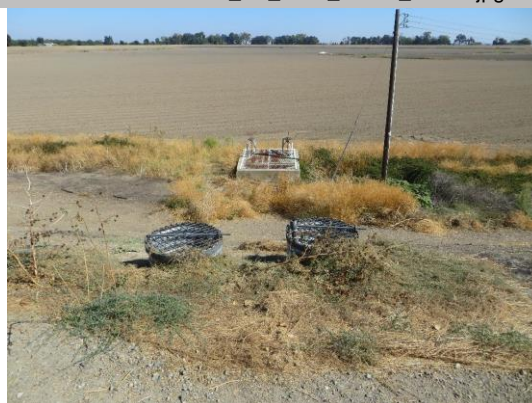
Photo 2 of 3 : UCIP_FA_2018_46766_74706.jpg

Comment Code						
Inspector Comment						
FS_ID:46766 DS_ID:25126 EP_NO: 8501 Repair Type: Non-Urgent Crossing Status: Found UCIP Comments: a few actions are recommended based on field inspection: 1. clear out metal fence posts near daylight of pipe on water side levee. 2. clear vegetation around pipes on water side of levee to aid in inspection. 3. monitor burrowing activities on water side of levee. FIELD_STRUCT_DESC: 2 of 2: 20-inch steel irrigation pipe, at an unknown depth, and 16-inch steel irrigation pipe, at an unknown depth, are located at levee mile 6.889 and 6.89, respectively. Both pipes have a protective paint coating. The pipes are used to supply irrigation water to the adjacent fields. On the waterside (WS) of the levee, the pipes are above ground and follow the slope of the bank into the river. A metal pump house, supported on a steel frame, is located on a bench on the WS of the levee. When the pumps are operational, a drum fish screen is lowered over the pipe intakes on a track. Both irrigation pipes travel through the levee and have siphon breakers inside corrugated metal riser units on the landside (LS) crest of the levee. The pipes discharge under submerged conditions to a 9.5-foot by 12-foot concrete distribution box. There are two gated outlets on the distribution box that lead to distribution canals. FS Date: 10/9/2015

view from levee crest along pipe looking towards land side. shows siphon breaker standpipes and distribution box.

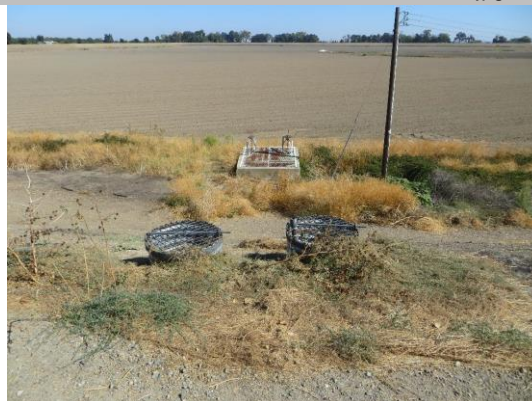
Photo 2 of 3 : UCIP_FA_2018_46765_74701.jpg

Comment Code						
Inspector Comment						
FS_ID:46765 DS_ID:25125 EP_NO: 8501 Repair Type: Non-Urgent Crossing Status: Found UCIP Comments: field inspection of the site revealed a few minor actions: 1. there are metal fence posts located near the pipe that should be cleared out for safety, 2. vegetation around the pipes should be cleared as it limits inspection, 3. some burrowing activity was noticed nearby the pipes. FIELD_STRUCT_DESC: 1 of 2: 20-inch steel irrigation pipe, at an unknown depth, and 16-inch steel irrigation pipe, at an unknown depth, are located at levee mile 6.889 and 6.89, respectively. Both pipes have a protective paint coating. The pipes are used to supply irrigation water to the adjacent fields. On the waterside (WS) of the levee, the pipes are above ground and follow the slope of the bank into the river. A metal pump house, supported on a steel frame, is located on a bench on the WS of the levee. When the pumps are operational, a drum fish screen is lowered over the pipe intakes on a track. Both irrigation pipes travel through the levee and have siphon breakers inside corrugated metal riser units on the landside (LS) crest of the levee. The pipes discharge under submerged conditions to a 9.5-foot by 12-foot concrete distribution box. There are two gated outlets on the distribution box that lead to distribution canals. FS Date: 10/9/2015 9:00:32 AM

view from levee crest along pipe profile toward land side of levee. CMP risers with siphon breakers and distribution box near land side levee toe.

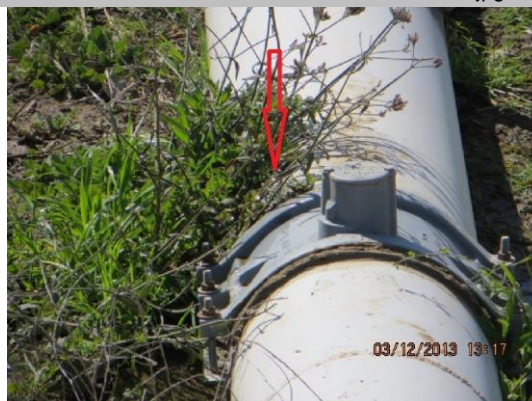
Photo 1 of 3 : UCIP_FA_2018_10129_17291.jpg

Comment Code					
Inspector Comment					
FS_ID:10129 DS_ID:20228 EP_NO: 1297 Repair Type: Non-Urgent Crossing Status: Found UCIP Comments: Leak at flowmeter on WS berm may become problem in near future. FIELD_STRUCT_DESC: *REMOVED* 2 of 2: 16-inch steel irrigation pipe through the levee, 5.2 feet below the crown. Slant pumps in a metal pump house on the waterside (WS) bank, supported on a steel structure. Pipes discharge into a 9.5-foot by 12-foot concrete distribution box on the landside (LS). Sparline flow meter on pipes near the WS toe. (Permit No. 1297, 1948 - River Farms Company of California; removed under Permit No. 8501, 2012 - River Garden Farms, Inc.). [Additional Reference(s): DWR Levee Log, 2006. USACE Sacramento O&M Manual 130, May 1960 (HLM 6.89) listed as a 14-inch pipe]. FS Date: 3/12/2013

Minor leak at flowmeter on WS berm.

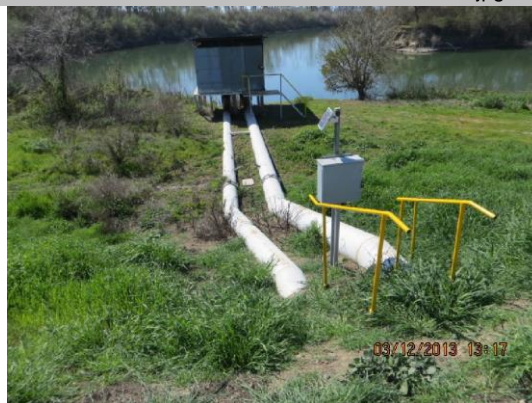
Photo 2 of 3 : UCIP_FA_2018_10129_17290.jpg

Pumphouse and steps on WS.

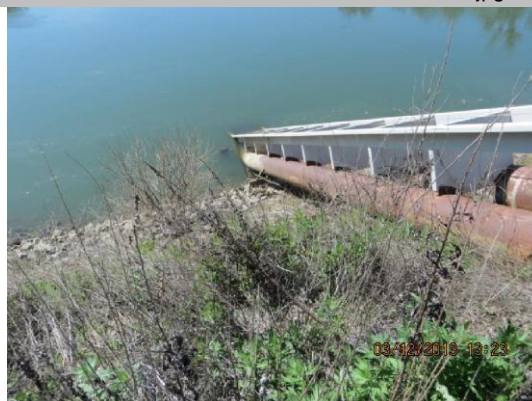
Photo 3 of 3 : UCIP_FA_2018_10129_17289.jpg

Comment Code						
Inspector Comment						
FS_ID:10129 DS_ID:20228 EP_NO: 1297 Repair Type: Non-Urgent Crossing Status: Found UCIP Comments: Leak at flowmeter on WS berm may become problem in near future. FIELD_STRUCT_DESC: *REMOVED* 2 of 2: 16-inch steel irrigation pipe through the levee, 5.2 feet below the crown. Slant pumps in a metal pump house on the waterside (WS) bank, supported on a steel structure. Pipes discharge into a 9.5-foot by 12-foot concrete distribution box on the landside (LS). Sparline flow meter on pipes near the WS toe. (Permit No. 1297, 1948 - River Farms Company of California; removed under Permit No. 8501, 2012 - River Garden Farms, Inc.). [Additional Reference(s): DWR Levee Log, 2006. USACE Sacramento O&M Manual 130, May 1960 (HLM 6.89) listed as a 14-inch pipe]. FS Date: 3/12/2013

Pipe and fish screen ramp on WS.

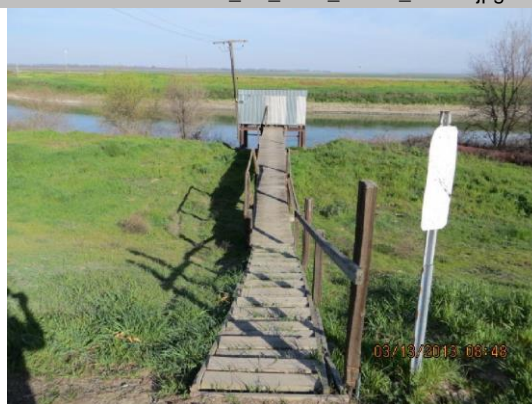
Photo 2 of 3 : UCIP_FA_2018_10144_17306.jpg

Comment Code						
Inspector Comment						
FS_ID:10144						
DS_ID:20428						
EP_NO: 18206						
Repair Type: Non-Urgent						
Crossing Status: Found						
UCIP Comments: Flap gates rusted through at concrete distribution box on LS toe.						
FIELD_STRUCT_DESC: 1 of 2: 20-inch steel irrigation pipe through the levee, 4.7 feet below the crown. Slant pump inside pump house on the waterside (WS) berm. Siphon breaker inside corrugated metal riser unit on the shoulder. Flap gate on pipe inside concrete distribution box on the landside (LS). Wooden steps on both slopes. (Permit No. 18206, 2007 - River Garden Farms). (Replaced 20-inch pipe installed under Permit No. 9377, 1974 - Faye Properties, Inc.). [Additional Reference(s): DWR Levee Log, 2006].						
FS Date: 3/13/2013

Stairs and pump on WS.

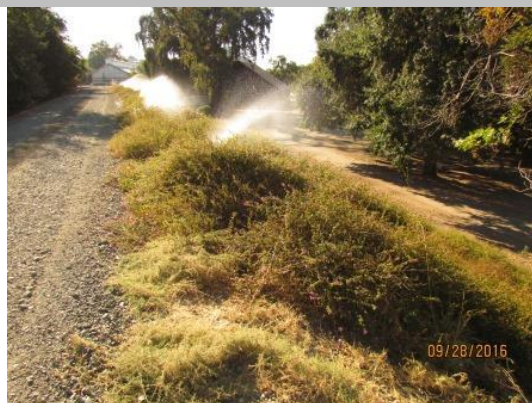
Photo 2 of 2 : FA_2018_NA0016_435_173_20180904_00050.jpg

Irrigated landscaping on landside slope of the levee reaching levee crown. Fall 2016 inspection.

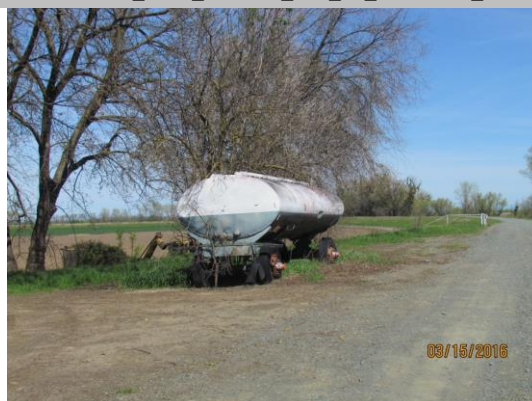
Photo 2 of 2 : FA_2018_NA0016_435_26_20180904_00006.jpg

View of the equipment on the crown of the levee looking upstream.
Spring 2016.

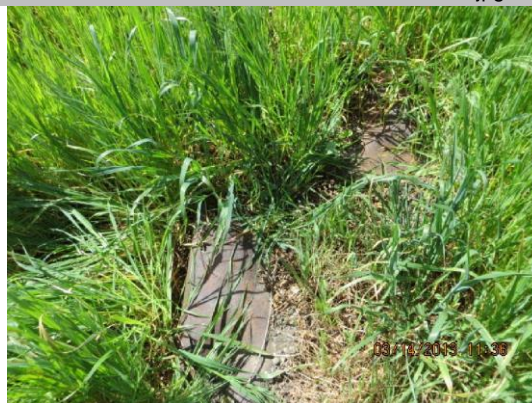
Photo 2 of 2 : UCIP_FA_2018_10290_17544.jpg

Pipe debris on WS slope.

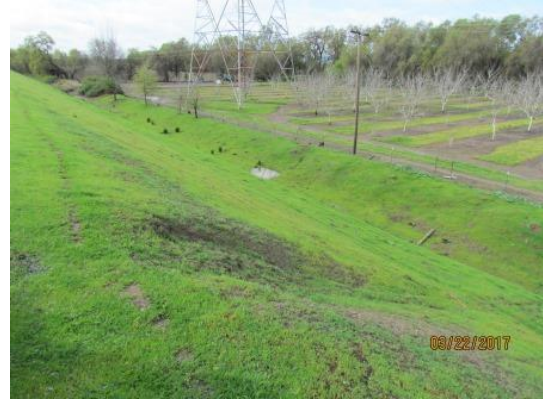
Photo 1 of 2 : FA_2018_NA0016_435_146_20180904_00046.jpg

Slope stability issue due to foot traffic. Spring 2017.

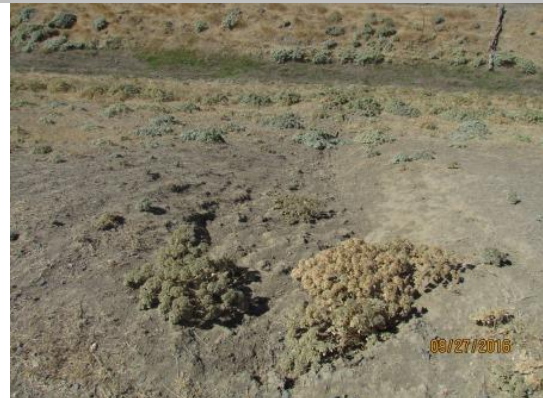
Photo 2 of 2 : FA_2018_NA0016_435_146_20180904_00047.jpg

Slope stability issue due to foot traffic. Fall 2016 inspection.

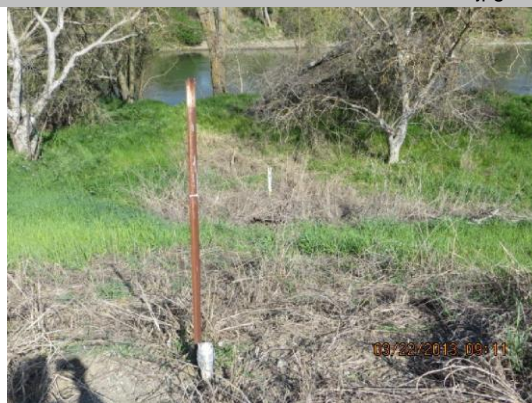
Photo 1 of 3 : UCIP_FA_2018_46812_17909.jpg

Broken fresno valve on WS shoulder

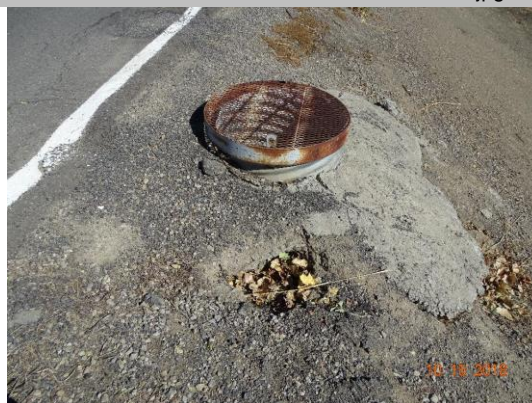
Photo 3 of 3 : UCIP_FA_2018_53020_78176.jpg

A sinkhole next to CMP riser on LS shoulder.

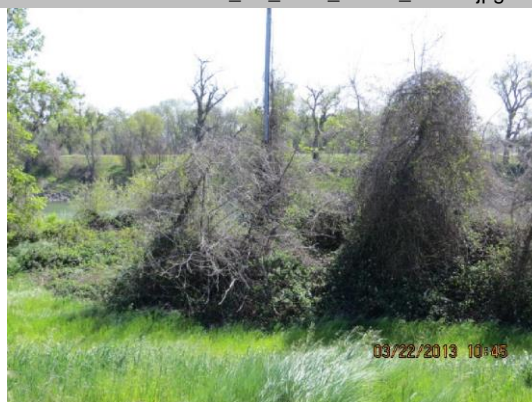
Photo 2 of 3 : UCIP_FA_2018_10566_17953.jpg

Pump covered in brush on WS berm.

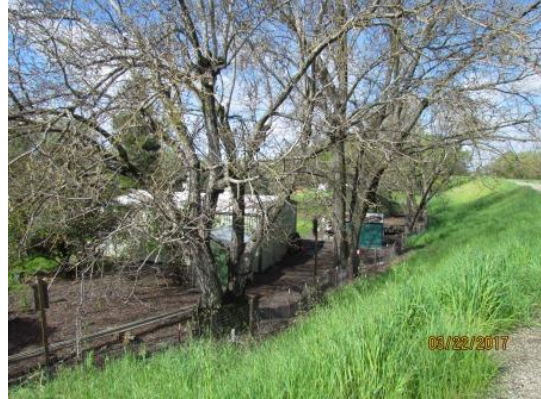
Photo 1 of 1 : FA_2018_NA0016_435_199_20180904_00051.jpg

Fence along landside levee toe blocking access. Spring 2017.

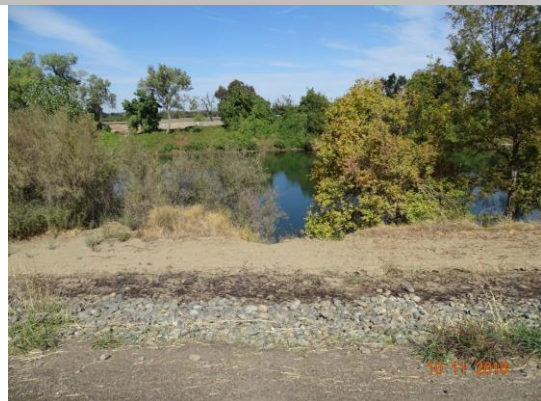
Photo 1 of 1 : FA_2018_NA0016_435_113_20181011_00229.jpg

View of erosion on the waterside berm. Fall 2018.
